# BELZONA REPAIRS DAMAGED FEET OF A PULPER

ID: 7817

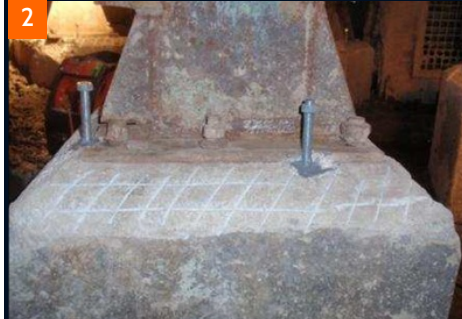
The five feet of a paper mill pulper and the concrete blocks underneath were badly damaged. The bolts keeping the feet in place on the concrete blocks were badly corroded. The whole equipment was no longer resting safely on the concrete base.

Before application

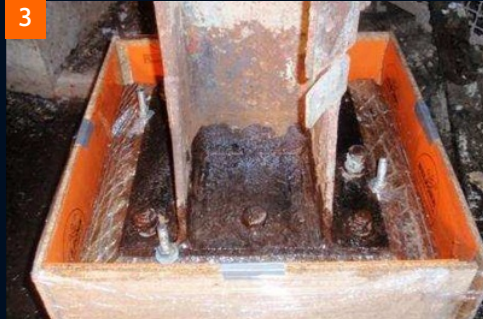
Threaded rods bonded with Belzona 1111  
after surface preparation

The whole surface that needed to be repaired was high-pressure washed, then a needle gun was used to get rid of the rust and the metallic parts were roughened with a metallic brush. The needle gun and a diamond disk were also used to prepare the concrete and ensure a good mechanical adhesion. Belzona 1111 was then used to bond threaded rods to keep the feet in place and enhance the adhesion of Belzona 4111, in accordance with Belzona System Leaflet GSS-08. Belzona 4911 was then used on the whole surface and a former was placed all around the concrete blocks. Belzona 4111 was poured into the former in several packed layers, and once cured, the former was taken off.

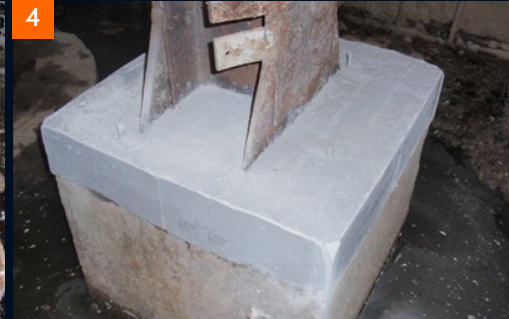
Conditioner and former installed
