# BELZONA REMEDIES DAMAGE CAUSED BY A BROKEN PISTON ROD

ID: 7822

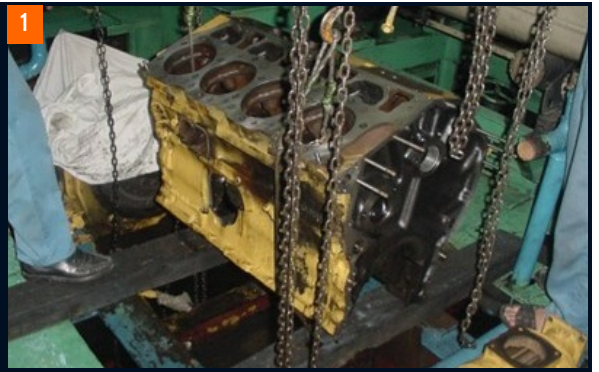
Engine block removed and hoisted into position

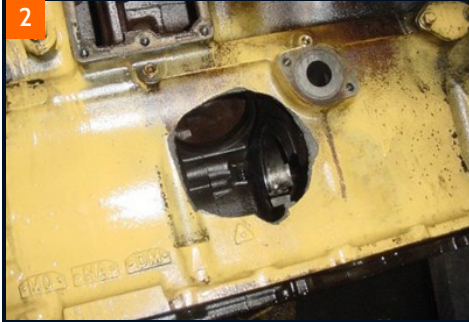
A broken piston rod had caused damage to the engine casing, resulting in a large hole.

Close up of the defect

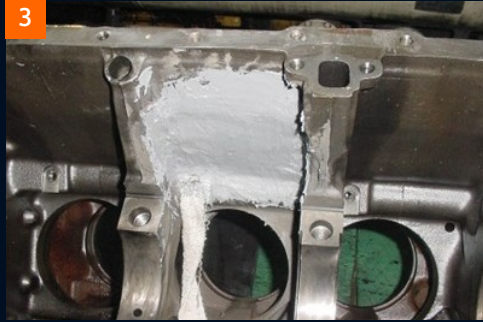
Plate bonding with Belzona 1111

Application was carried out in accordance with Belzona System Leaflet ENC-1.

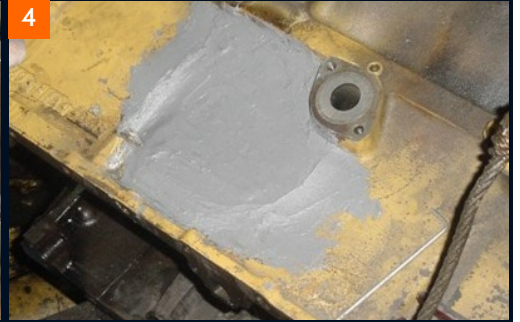
Completed application
