# BELZONA REPAIRS DUCT ON FPSO

ID: 7869

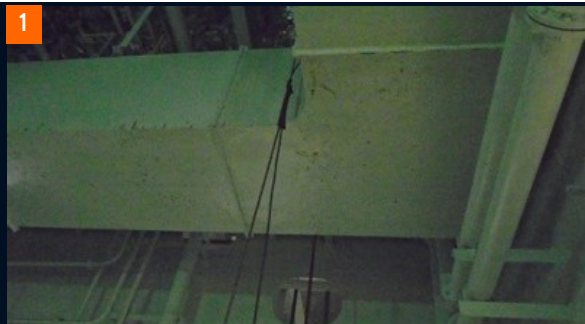
The ER Duct from the compressor was damaged from severe corrosion leading to holes in some areas.

Severe corrosion affected the ER Duct lines creating holes and metal loss. Atmospheric air is the medium that passes through duct.

1. General view of the ER Duct.
2. Surface preparation on the ER Duct.
3. Application of Belzona 9111 degreaser-cleaner.
4. Applied Belzona 1111 to rebuild lost metal and Belzona 5811 to protect surface corrosion.
