# BELZONA REALIGNS A PUMP IN A CHEMICAL PLANT

ID: 7871

Damaged concrete block underneath a pump.

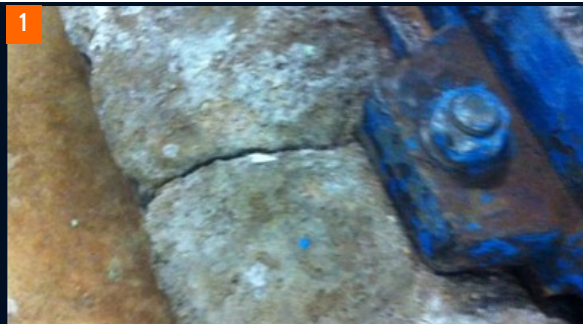
A pump sitting on a concrete block was no longer properly aligned causing shear stress.

1. Showing damage.
2. After the surface preparation.
3. Belzona 4111 applied.
4. Belzona 7111 applied.
