# BELZONA REPAIRS WORN OUT FAN SHAFT DUE TO ABRASION AND BEARING SEIZURE

ID: 7875

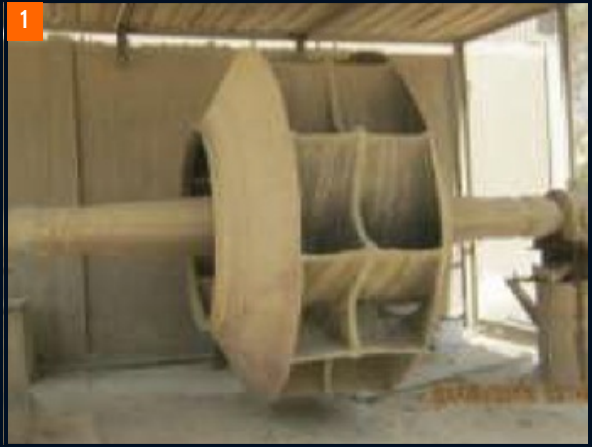
Deeply worn out due to abrasion in Fan shaft due to abrasion and bearing seizure.

1. General view of the Fan shaft.
2. Wear area in Fan shaft.
3. Fabricated former to get the required dimensions.
4. Application Done.
