# BELZONA REPAIRS WORN OUT FAN SHAFT

ID: 7877

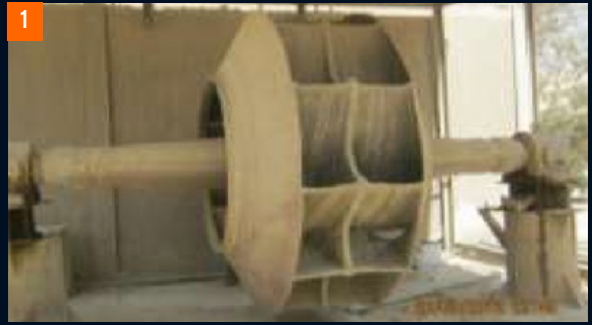
General view of the fan shaft.

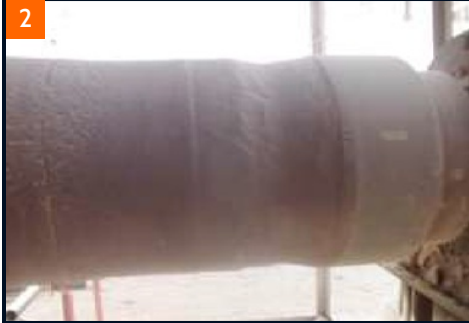
Deeply worn out due to abrasion in Fan shaft due to abrasion and bearing seizure which prevented the equipment from operating efficiently.

A Fan shaft had failed due to abrasion from the process, and the bearings had seized in service.

Wear area in fan shaft.

The application was carried out in accordance with a modified version of Belzona Know-How System Leaflet MPT-2 for rebuilding damaged shafts using forming techniques. The area was prepared using a disk grinder to roughen the surface and to make a cross-hatching pattern on the surface. A coat of Belzona 9411 was applied to the inside of the formers, and the edges where material will be pushed out. Belzona 1111 was applied to the shaft and covered the entire area using a brush and the mixing spatula to apply the product. Also, the inside of the formers were covered and evenly spread. The formers were clamped to the shaft. Once Belzona 1111 had cured the former was removed.
