# BELZONA FORMS THE FACES OF 132 SEA WATER FLANGES

ID: 7879

Petrochemical Plant, Saudi Arabia

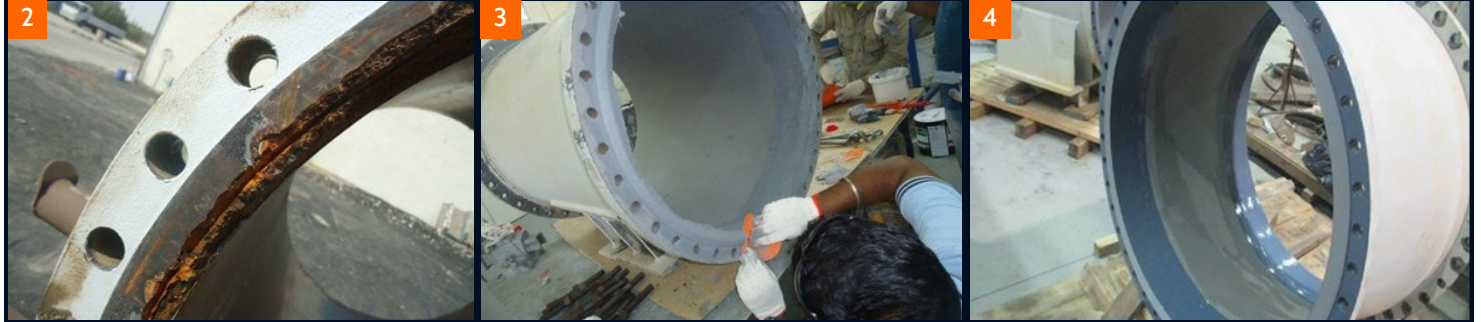
A new utility sea water cooling facility was commissioned 1 year ago for this plant. Already, the effects of sea water were leading to crevice corrosion on many diameters of pipe line flanges. This was leading to worn out serrations and severe damages on the seating faces. Existing FBE coating failure inside the spools was due to sea water penetration and pitting corrosion on the edges of spool. Leakages observed through various flange faces / weld seams were leading to intermittent shutdowns.

1. Sea water leaking through the flanges
2. Flange damage on the edges
3. Application of Belzona 1111 (Super Metal) on the flange to form peaks
4. 48 inch completed application

The flanges were formed in accordance with VPF-17.
