# BELZONA SAVES IMPELLER AFTER CHEMICAL EXPOSURE

ID: 7907

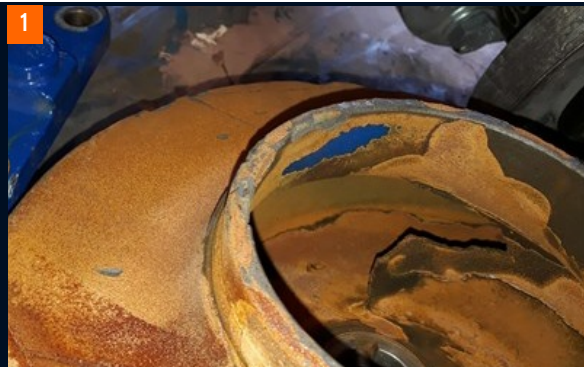
A pump and impeller were badly damaged by accidental contamination with sulfuric acid at 20% concentration. Lead time for a new unit was 12 weeks, leaving the end user with an expensive period of prolonged downtime. The impeller needed rebuilding to make it operational, and then coating to protect from any further incidental contact.

- 1- Corroded impeller
- 2- Close up of interior damage
- 3- Profile after grit blasting
- 4- Completed repair after coating

Substrate was grit blasted to 75 microns and cleaned to SA 2.5. The damaged areas of the impeller were then rebuilt, to as near to the original profile as possible, using Belzona 1311. Some areas were required rebuilding due to the extensive damage. Once the Belzona 1311 had cured, two coats of Belzona 4311 were applied to protect against further incidental contact. This was completed in accordance with Belzona System Leaflet CEP-1.
