# BELZONA REPAIRS GRAYLOC FLANGE DAMAGE IN WATER INJECTION LINE

ID: 7967

Riser connection flange on FPSO top side, operating at 345 bar pressure up to 60°C.

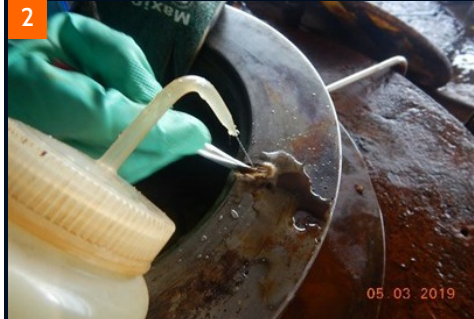
The topside end fitting connection joint on the riser used a Grayloc system to contain the high pressure. Due to a material defect a small area on the gasket had worn away, causing a leak.

1. Defect area
2. Cleaning in progress
3. Area built up with Belzona 1111
4. Repair made level and smooth with abrasive paper
