# GRAPHITE HEAT EXCHANGER RESTORED WITH BELZONA

ID: 7987

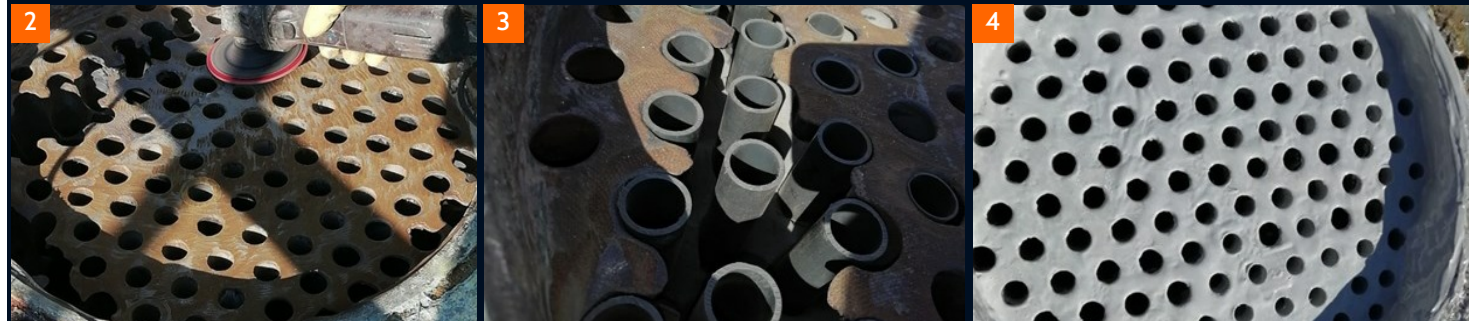
The tube sheet and some of the tubes have been severely damaged due to a combination of chemical and erosive attack. The loss of material causes a reduction in the thermal efficiency of the heat exchanger. Replacement is an expensive option.

1. Damaged Heat Exchanger Tube Sheet  
2. Surface Preparation with mechanical grinder  
3. PVC pipes in place  
4. Completed repair

The surface was prepared using a mechanical grinder to remove contamination, getting back to clean & strong graphite, and achieving a rough surface. PVC tubes were inserted to form a mold around which the Belzona material can be poured, to restore the tube sheet back to its original surface. Belzona 1391T was poured into the damaged areas, restoring the surface dimensions, and used to coat the entire surface, protecting from further damage. The application was carried out in accordance with a modified version of Belzona System Leaflet HEX-01 and HEX-03.
