# IN-SITU BELZONA SHAFT REPAIR AT CEMENT PLANT

ID: 8057

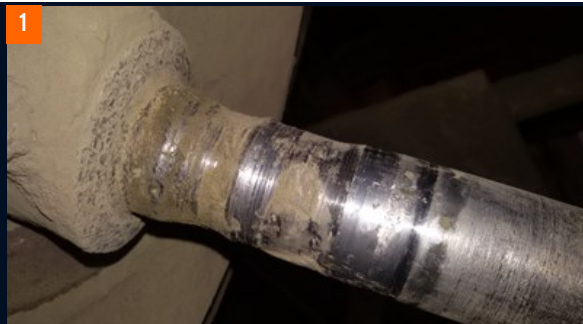
Heavy wear of the shaft on the cement screw element had occurred and required repairing before potential equipment failure.

Worn cement screw shaft 1 1/2" diameter

1. Worn shaft
2. Shaft area prepared for application
3. Former clamped in position after Belzona 1111 application
4. Former removed revealing fully cured Belzona 1111 repair
