# BELZONA SEALS LEAK IN WIND TURBINE TOWER

ID: 8068

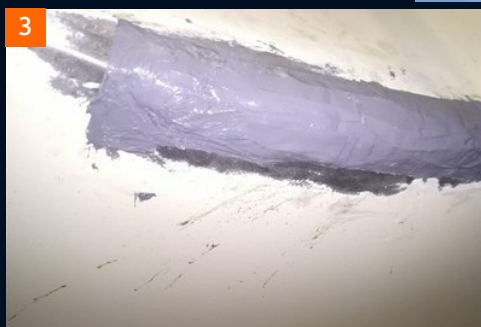
A crack along a weld seam had lead to an oil leak from a bund which is used to contain lubricant oil used for the bearings and gearbox. Loss of containment can cause damage to surrounding equipment and a hazard to personnel climbing the tower.

1. Wind Turbine view from the ground
2. View from the top of the tower
3. Leak sealed with Belzona 9611
4. Completed repair

The application was carried out in accordance with a modified version of Belzone Know-How System Leaflet TCC-1. The surface was thoroughly cleaned, the crack was terminated by drilling holed on each end. The surface was then abraded by mechanical tools before the leak was plugged using Belzona 9611. Once the Belzona 9611 has cured, Belzona 1212 with Belzona 9341 (Reinforcement Sheet) was used to ensure a long lasting repair.
