# BELZONA BALL MILL TRUNNION REPAIR

ID: 8074

Repair of the trunnion section of a grinding mill

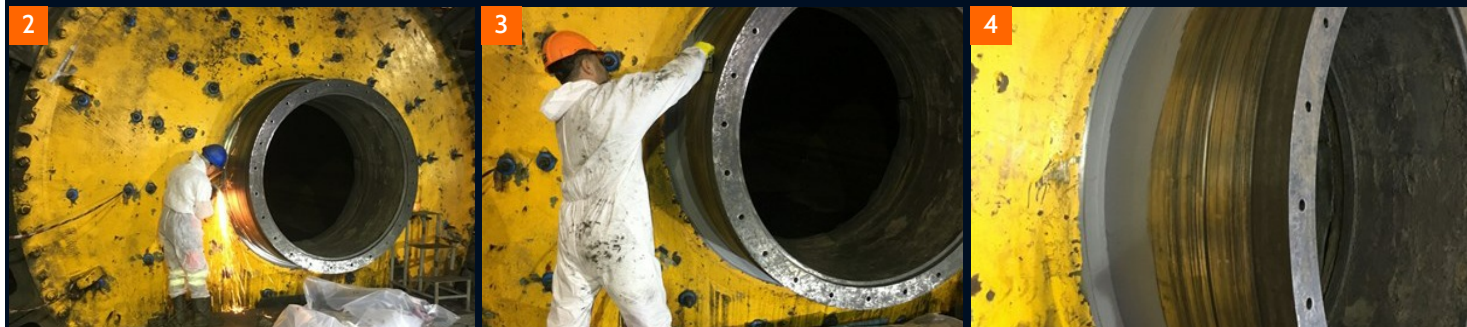
Wear caused over time by the rotating mill grinding against the trunnion section. Also abrasion from the minerals and ores being ground as part of the mining process.

1. Damaged trunnion section
2. Surface preparation using an MBX
3. Applying the Belzona 1121
4. Final application

Application carried out using a modified version of system leaflet MPT-07. An MBX bristle blaster was used to prepare the surface, allowing the paste grade to adhere to the substrate. 17 Kg's of Belzona 1121 was then applied around the circumference of the trunnion section and smoothed out with an applicator to rebuild the lost materials.
