# BELZONA REPAIRS FERTILIZER TANK

ID: 8082

Repair of a tank used for fertilizer production.

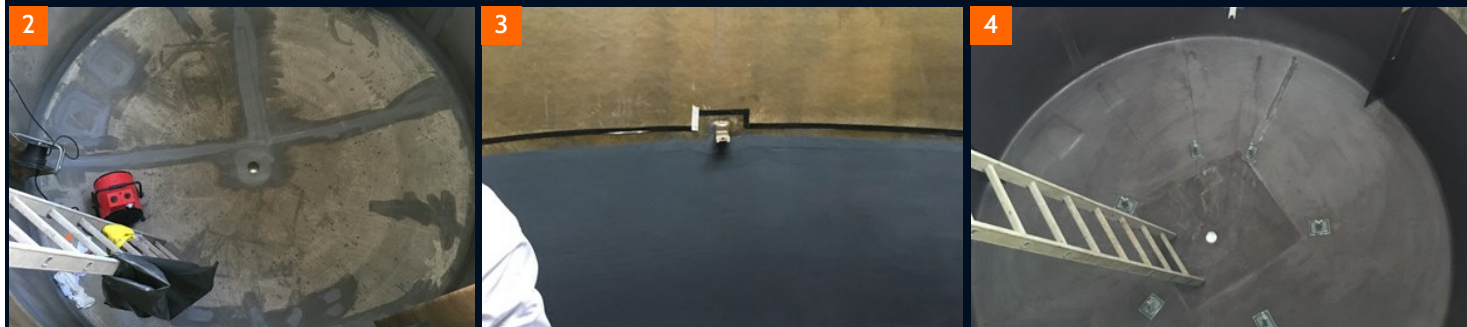
An existing fiberglass lining had failed at the bottom of the tank due to not having the correct chemical resistance for the range of chemical circulating the tank. The failed lining resulted in a loss of material at the base of the tank and also leaving the substrate unprotected and exposed to further chemical attack.

1. Failed fiberglass lining due to chemical attack
2. Rebuilding with Belzona 1111
3. First coat of Belzona 4311
4. Finished application

This application was carried out in accordance with system leaflet TCC-03. The fiberglass coating was removed and the substrate was blasted to SA 2.5 before rebuilding the lost profile with Belzona 1111. Belzona 4911 was used to condition the surface before 2 coats of Belzona 4311 were applied to prevent future chemical attack from occurring.
