# BELZONA IMPELLER REPAIR

ID: 8086

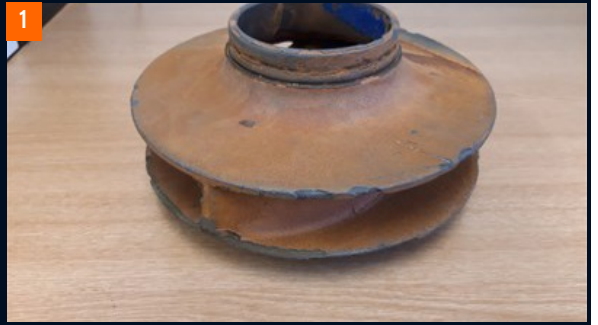
The pump and impeller were corroded due to contact with sulfuric acid at approximately 20% concentration, caused by back feed into the system, with the primary contact of waste or rinse water.

1. Damaged impeller with corrosion after being exposed to sulfuric acid and water.
2. Impeller profile restored using Belzona 1311 (Ceramic R-Metal).
3. Belzona 4311 (Magma CR1) coated impeller.
4. Side-view of the finished coated and rebuild impeller.

Application carried out as per Belzona Know-How System Leaflets CEP-1 & CEP-3. Surface contamination was removed and degreased with Belzona 9111, then blasted the surface to achieve SA 2 ½. The impeller was then rebuilt to profile using Belzona 1311 and reinforcing materials. Two coats of Belzona 4311 was then applied to protect against further chemical attack.
