# BELZONA REPAIRS LEAKING TANK ROOF

ID: 8101

Sealing holes on the roof of an oil tank.

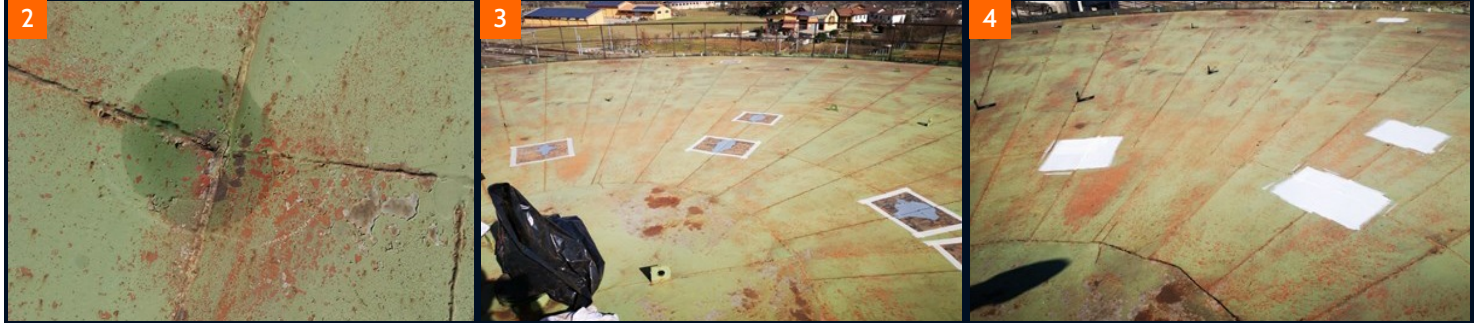
A tank roof has failed and started corroding at the weld seams. This was allowing water to seep in through these holes causing contamination problems for the solution within the tank.

Previous welding had introduced heat activated zones into the tank roof resulting in weakness and corrosion at the weld seams. Welding the tank again would have created the same problems and that's why the Belzona cold applied solution was used.

1. Overview of the tank roof
2. Water ingress at the weld seams
3. Belzona 1161 being applied
4. Finished application with Belzona 3111

This application was carried out in accordance with system leaflet TCC-02. Areas where the tank roof was leaking from were identified and taped out. Once taped out the surface was prepared using an MBX bristle blaster. Belzona 1161 was then used to fill in the leaks before Belzona 3111 was applied on top with a cut out strip of Belzona 9311 reinforcement sheet for added protection.
