# DAMAGED STAIR NOSING AT DISTRIBUTION CENTER

ID: 8153

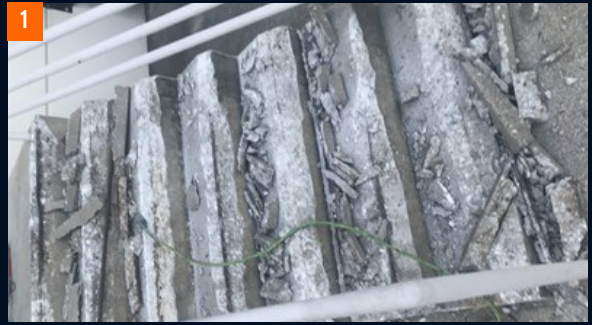
Years of salting the nosings lead to the concrete cracking. The cracks let water in and caused expansion in the concrete and the rebar starting to corrode leading to the steps falling apart. The area is a critical path for the drivers to come in, and causing a safety issue.

1. Removal of old cracked concrete
2. Application of 4141
3. Application of 5231
4. Application of 5233

Substrate was jackhammered to remove all the loose concrete. Once the loose concrete was removed, any exposed rebar was cut out and the area was conditioned with Belzona 4911, in preparation for Belzona 4141. After Belzona 4141 was applied and allowed to cure, then first coat of 5231 was applied. After application, a colour quartz was applied to provide a non-slip surface. Next day top coat of 5233 tinted grey was applied.
