# BELZONA REBUILDS SEAWATER FILTER FLANGES

ID: 8155

Seawater filters of a container ship.

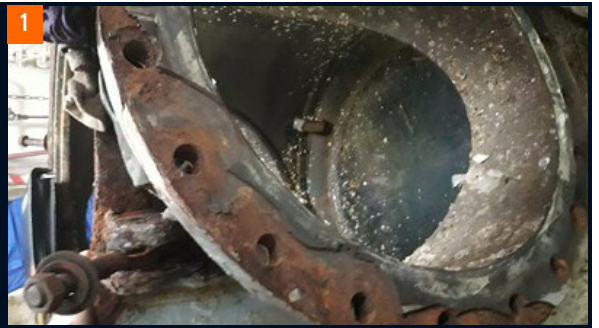
Pitted surface and metal loss due to erosion and corrosion on the seawater filter flange.

1. Erosion and corrosion damage on the flange.
2. After surface preparation.
3. Application of Belzona 1111 (Super Metal) with applicator.
4. After Belzona application.
