# BELZONA REPAIR AND PROTECTS PROPELLER SHAFTS

ID: 8156

Ro-Ro Ship propeller shaft.

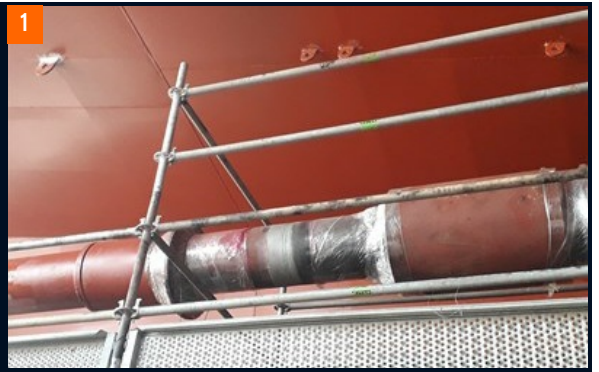
Cavitation damage on the propeller shaft.

1. Cavitation damage on the propeller shaft.
2. After surface preparation.
3. Repair with Belzona 1311.
4. Coating application with Belzona 1321.
