# BIOMASS PLANT PIPE REPAIRS

ID: 8163

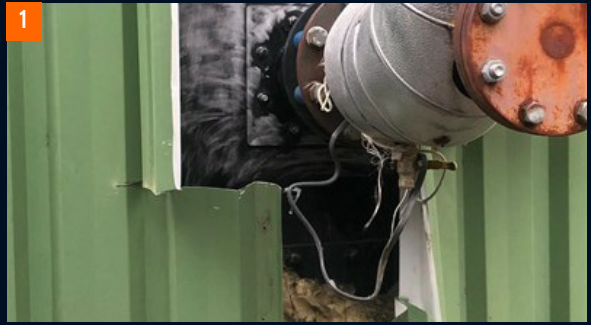
Following NDT testing of a digester feedpipe, it was found that internal corrosion has caused the pipe wall thickness to approach the minimum allowance. A repair was required to reinforce this pipe without shutting down & dismantling the pipework.

1. Surface preparation underway
2. SuperWrap 2 consolidated
3. Completed repair
4. Repair in place 5 years later

The area was prepared to SSPC SP11 using a mechanical abrasion cleaning process. Belzona 1982 was applied along with Belzona 9381 composite reinforcing sheet. A wrap system was applied to the feedpipe along with a patch system terminating onto the tank. Bracket bolts were patched around. The repair was then consolidated with Belzona 9382. The repair was done on a 'standard' SuperWrap II basis.

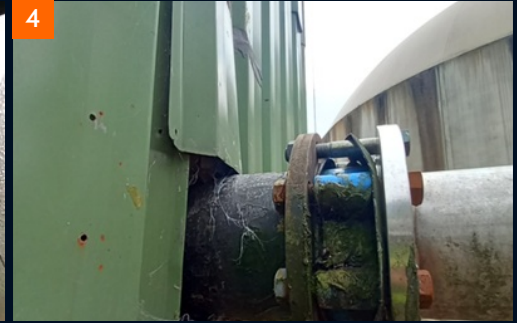
Using this system was much safer than welding & much quicker than dismantling & replacing the pipework. The repair was viewed onsite 5 years following the application & is in good condition.
