# TUGBOAT REAR REBUILD, REINFORCEMENT AND PROTECTION USING BELZONA

ID: 8236

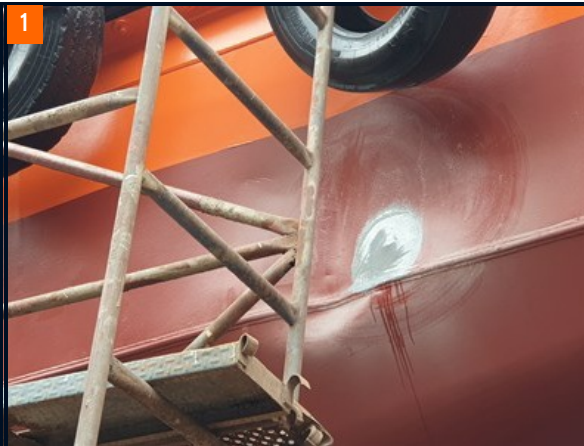
The Tugboat had sustained major damage during a dock manoeuvre. This resulted in a dock bumper perforating the external wall at the rear of the boat. This subsequently damaged the supports of an internal vessel storing a fire-retardant substance.

1. Rebuild of the perforated wall
2. Damage sustained to the internal vessel supports
3. Rebuild & reinforcement to the supports
4. Protective coating applied to protect the repair from future corrosion

The rear necessitated an external rebuilt of the perforated wall using Belzona 1111, it was then protected against corrosion using Belzona 5811. The internal vessel required internal reinforcing of its supports using Belzona 1111 to give strength and prevent potential leaks, the repair area was then coated with Belzona 5811 to protect against corrosion. The application was carried out in accordance with Belzona System Leaflet SOS-01 and SOS-02
