# IMPELLER REFURBISHMENT COMPLETED BY BELZONA

ID: 8272

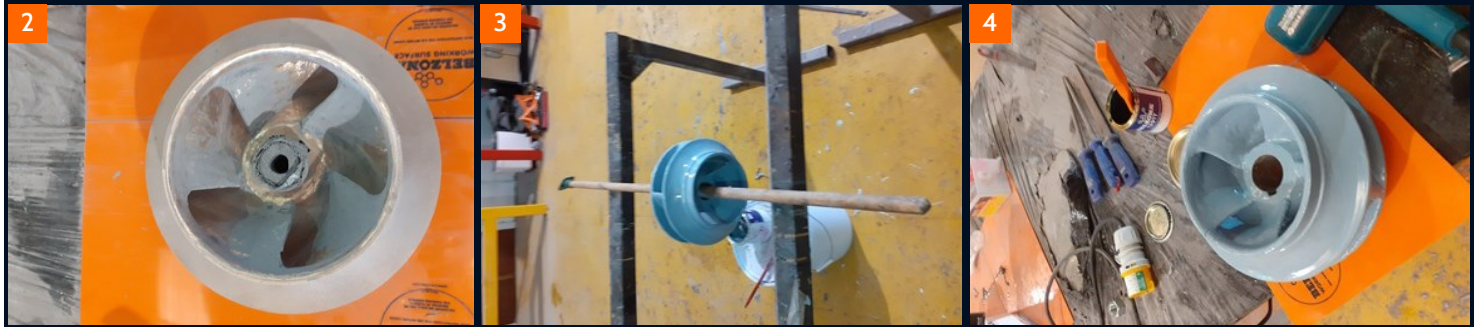
The impeller had eroded over time and now required re-profiling and a protective coating to protect the surface from the potential erosion in the future.

1. Rebuild in progress to blasted impeller
2. Impeller rebuild completed
3. First coat of Belzona 1391T completed
4. Completed Belzona repair and protection application

The substrate was prepared by conventional grit blasting to a minimum surface profile of 75µm and a surface cleanliness of SA 2½. The damaged areas were then rebuilt and re-profiled back to original using Belzona 1111. Once rebuilt, two coats of our Belzona 1391T were applied in accordance with Belzona Know-How System leaflet CEP-03.
