# REPAIR OF CAVITATION DAMAGE ON IMPELLER

ID: 8299

Impeller of Seawater Pump

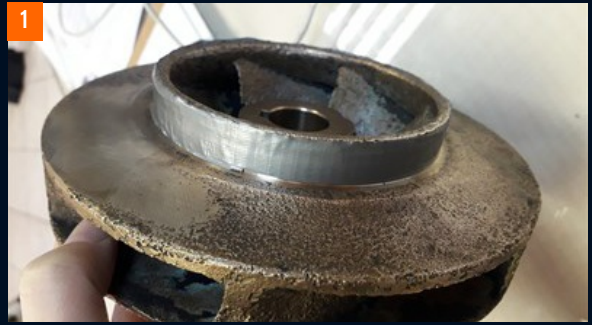
Due to cavitation damage of seawater, impeller has pitting damages on surface and blades causing low efficiency pumping.

1. Cavitation damaged surface
2. After surface preparation
3. Application of Belzona 1111
4. Application of Belzona 1321

Application was carried out in accordance with Belzona Know-How System Leaflet SOS-01 and SOS-02. Application surface was prepared with SA2½ grit blasting in workshop. Surface the cleaned with Belzona 9111. Belzona 1111 was used to repair the damaged impeller surface. Belzona 1321 was applied on top of Belzona 1111 and impeller surface within overcoating window, without the need of additional surface preparation.
