# BELZONA LINES INTERNALS OF A GAS MAIN

ID: 8345

Phase 5 lining of 96" site Gas main.

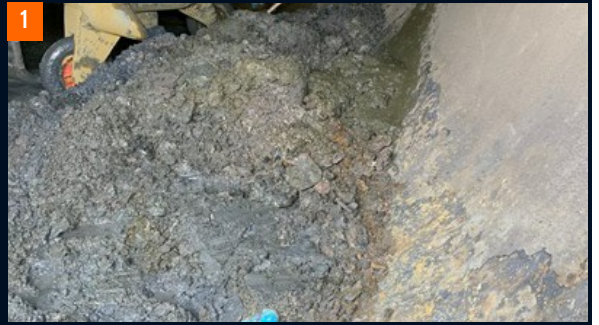
40 year old gas main has corroded internally, leading to leaks which are continually patched externally. In 2015 the site decided to line the 3km main in sections. For 2020, 350 linear metres were completed in 4 days.

1. Residue to be removed
2. Grit Blasting
3. Pits filled with Belzona 4154 (Bulk-Fill)
4. Finished Application

The main was cleared of residue that built up over the years. The whole pipe was cleaned and blasted to an SA 2.5, 75 micron profile, ready for the Belzona application. Any holes are over plated using 150mm<sup>2</sup> plates, bonded in position with Belzona 1151. The heavily pitted areas are filled with Belzona 4154 bulk fill material. The mix was achieved using 2 x units of resin to one bag of kiln-dried sand.
