# MAINTENANCE OF BELZONA COATED SEPARATOR AFTER 9 YEARS IN SERVICE

ID: 835

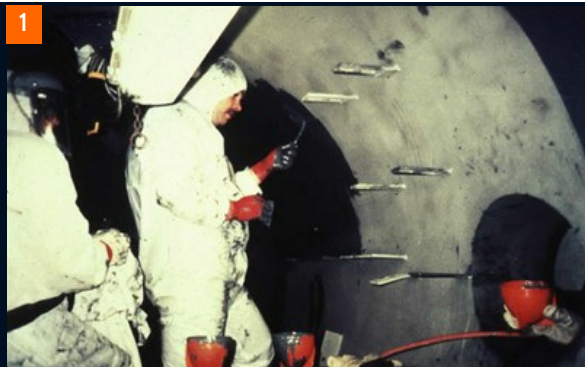
1. Vessel being coated in 1997.
2. Vessel inspection in 2006.
3. Vessel Inspection 2006.
4. Localised Repair 2006.

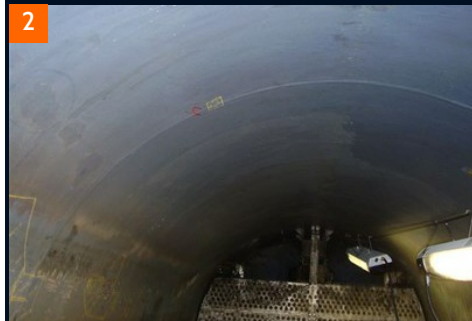
Previous glass flake system had failed and had suffered corrosion damage to the vessel wall. Belzona inspected after 9 years and only problems caused by local areas of mechanical damage.
