# BELZONA REPAIR OF FLOATING HOSES

ID: 836

Rubber covers and flotation/insulation on fuel hoses was damaged by ships propeller during fuel loading and unloading.

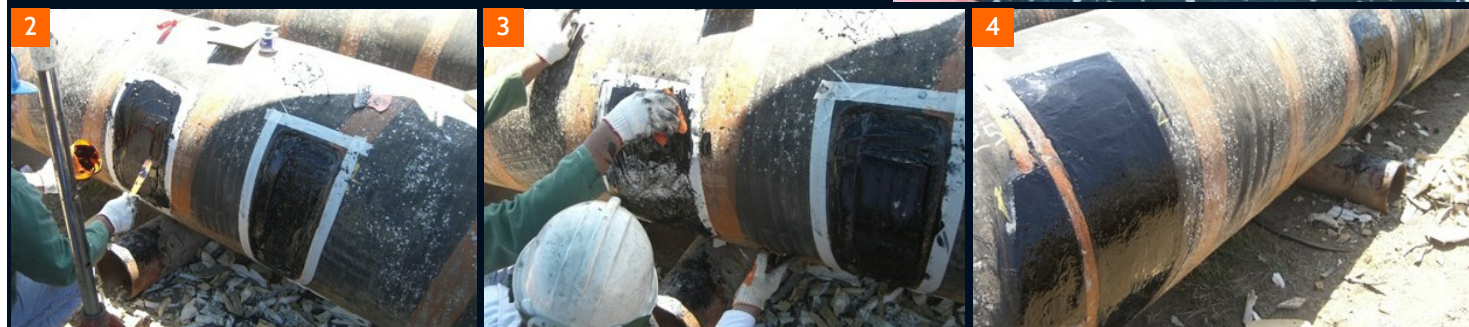
1. Typical damage
2. New insulation being bonded in with Belzona
3. Final outer cover build-up and coating
4. Completed repair

The repair was carried out in accordance with Belzona Know-How System Leaflet SOS-12.
