# CAVITATION DAMAGE IN PUMP REPAIRED

ID: 837

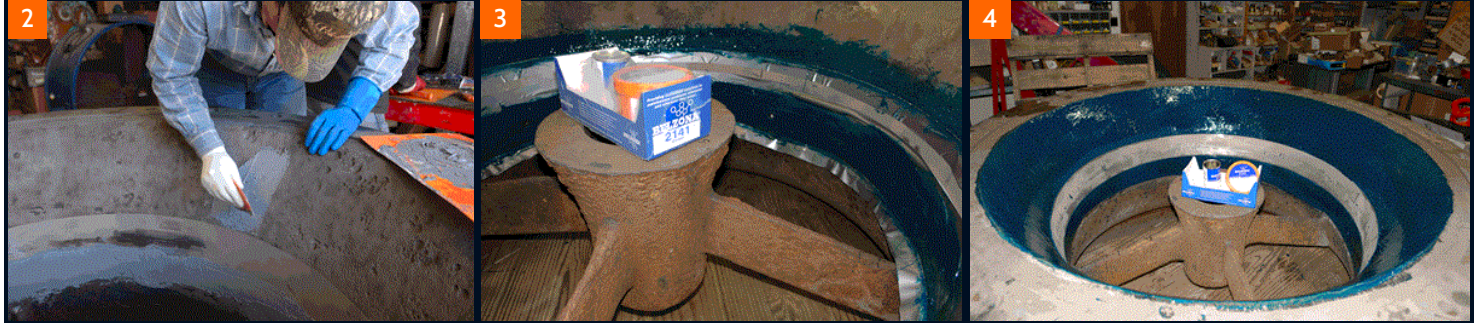
Severe cavitation erosion above and below wear ring. limited time to restore pump.

Suction bell of pump found to be cavitated during 1 week outage.

1. Extent of cavitation damage to suction bell, above and below wear ring
2. Repairing damage back to original dimensions
3. Repaired surface rebated, taped and half coated with Belzona 2141
4. Finished job ready for bushing installation then into service

Application carried out in accordance with Belzona Know-How System Leaflets CEP-3 and CEP-5. Rebate grooves were cut to terminate coating.
