# BELZONA SEALS AIR COOLER COVER

ID: 8389

Air Cooler Cover Connection Line

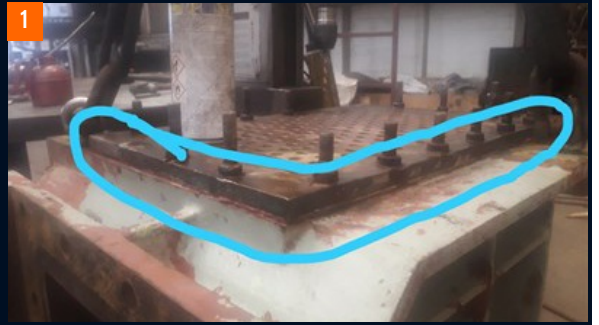
Due to the design of the Air Cooler, the gasket under the cover could not be changed. Over time and vibrations of Cooler, the deformed gasket lost its sealing and caused the performance of Air Cooler to decrease.

1. Leaking Area
2. Defining the application Area
3. Filling between cover and case with Belzona 2211.
4. After the application finished.
