# BELZONA 1111 REPAIRS TO CREVICE CORROSION

ID: 84

Flange faces of gas cooler

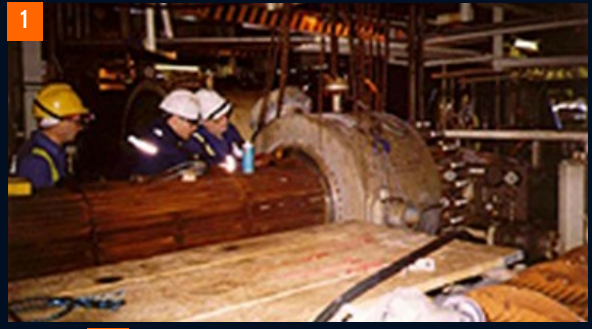
Incorrect joint material caused extensive crevice corrosion on two separate coolers

1. Inspection of the crevice corrosion being undertaken
2. Typical crevice corrosion pitting apparent on the flange face.
3. The Belzona repair completed without removal of the tube bundle
4. The time consuming alternative on-site machining after welding
