# BELZONA RESTORES TWO PUMP IMPELLERS

ID: 850

The two impellers had severe damage because a large bolt was left in the inlet of the pump

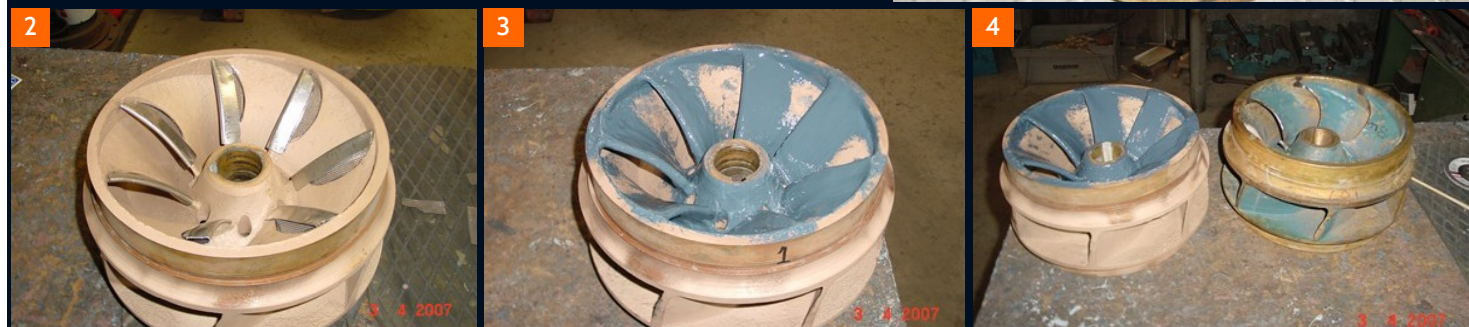
1. Damaged impeller
2. Stainless steel infill plates
3. Belzona 1111 used to bond plates and restore profiles
4. One repaired alongside one still to be repaired

Application was carried out in accordance with Belzona Know-How System Leaflets CEP-1 & 3. Steel plates were formed to recreate the lost vanes. Wire mesh was also incorporated into the Belzona rebuild as the original profile was restored. Repair was coated with Belzona® 1321 to give additional smoothness and erosion protection.
