# PUMP DIFFUSER REPAIRED USING BELZONA 1300 SERIES

ID: 8500

Sea water cooling system pump for thermal power plant.

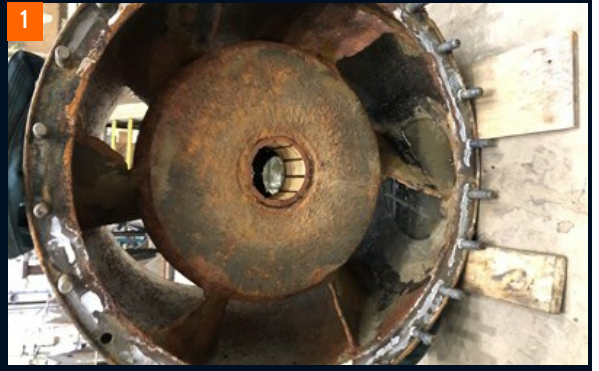
Corrosion and erosion from seawater was causing the leading edge of the diffuser vanes to wear away. Approximately 50 to 75mm of the leading edge was gone when this pump component was taken out for service. Weld repairs were not an option due to the steel alloy material.

1. Pump diffuser in poor condition on vane leading edges and widespread pitting.
2. Diffuser blasted and steel mesh tack welded into place to support Belzona 1311 rebuilding process.
3. Leading edges of the vanes re-built with Belzona 1311.
4. Diffuser fully coated with two coats of Belzona 1341 Supermetalgilde.

The application was carried out in accordance with Belzona Know-How System Leaflet CEP-1 to repair the leading edges of the diffuser vanes, and CEP-3 to line the internal surfaces to protect from the effects of corrosion, erosion, cavitation and provide some efficiency enhancement.
