# BELZONA REPAIRS 4KM LONG CONVEYOR BELT

ID: 8502

Repair of a 4km long conveyor belt at a copper mine.

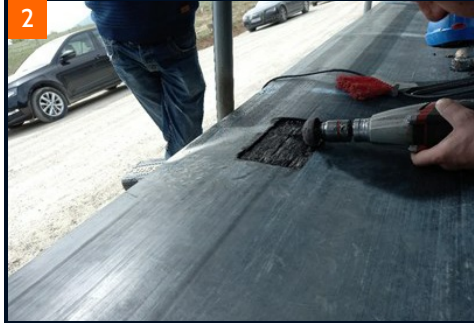
The track braking system of the conveyor belt failed causing copper ore to build up the belt. The hopper then became blocked and material began to flow out of the conveyor belt. Large pieces of ore jammed in-between the belt and driver roller causing the belt to rip in several places.
