# EMERGENCY FLANGE REPAIR

ID: 8523

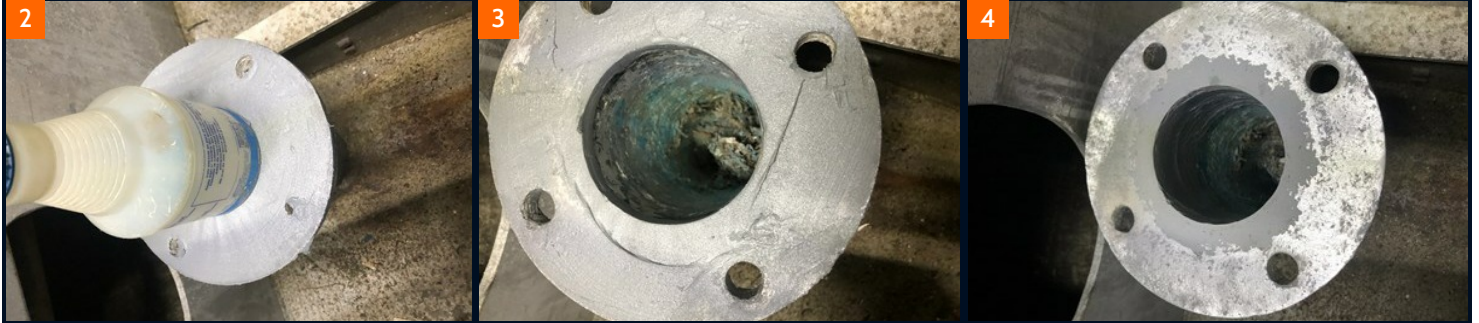
Erosion of the flange face caused ineffective sealing surface

- 1) Before application
- 2) Casting process
- 3) Cast removed
- 4) Flange sanded and ready to re-install

Prepared steel with wire wheel and angle grinder. De-greased and then scrubbed Belzona 1111 onto flange, building up pitted area. Applied Belzona 9411 to plastic bottle. Pressed Belzona 1111 into void around bottle. Sanded excess material back to original dimension.
