# SF6 GAS LEAK REPAIR WITH BELZONA

ID: 8533

In a wind farm in Australia, SF6 gas leaks were observed on flanges and needed to be sealed.

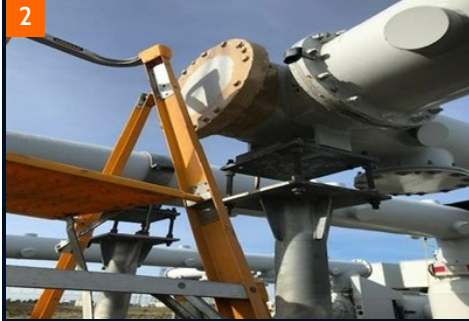
SF6 gas leaks were observed on flanges and needed to be sealed to prevent further leakage of this extremely potent greenhouse gas.

Picture 2: Leaking flange

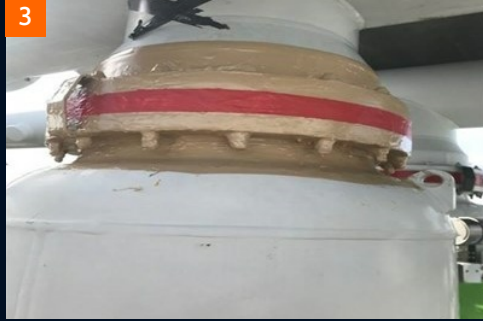
Picture 3: Application of Belzona 1161 & 5831

Surface was prepared with power tools, such as bristles blasters and grinders to achieve a good profile for the Belzona to adhere. Belzona 1161 and reinforcing tape was applied around the outside of the flange. Then all nuts and bolts were coated with Belzona 1161. Belzona 5831 was then applied over the Belzona 1161 repair area to ensure a good seal and dress up the application

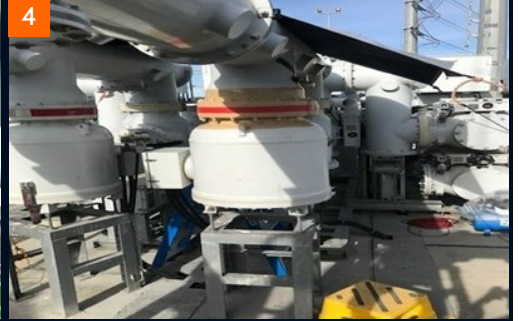
4: Completed flange gas leak repair

8 Flanges were successfully repaired, the client was happy and additional repairs will be carried out soon.
