# ENGINE REPAIR WITH BELZONA

ID: 854

Komatsu 900 loader.

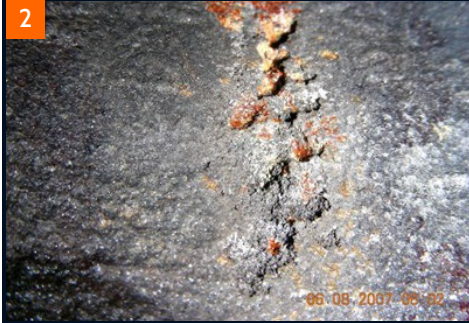
Erosion/corrosion on the cylinder block behind the cylinder liners allowed engine coolant to leak into the lubricating oil causing an engine failure.
