# BELZONA HELPS A MANUFACTURER OF AEROPLANE COMPONENTS

ID: 8542

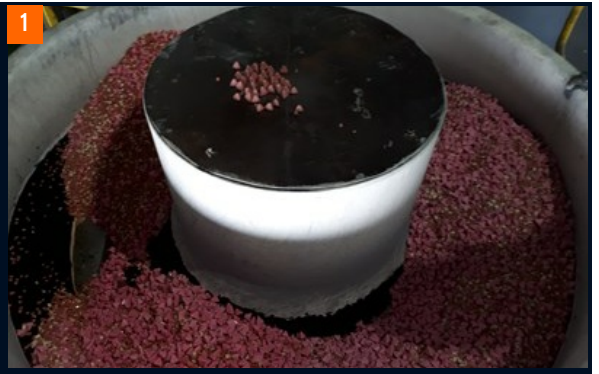
Severely damaged rubber linings. Presence of three cracks after surface preparation.

During inspection, localised damage to the rubber linings caused by wear and abrasion was noted

1 : Damaged rubber linings

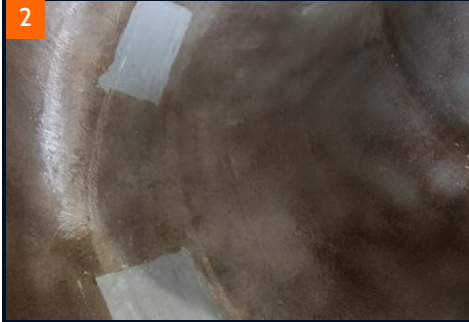
2 : Cracks repair with Belzona 1111 (Super-Metal) and Belzona 9341 (Reinforcement Tape)

The application was carried out in accordance with Belzona System Leaflets TCC-1 and CEP-3 Cracks were repaired with Belzona 1111 and 9341, then two coats of Belzona 2141 with reinforcement tape belzona 9341 were applied to replace the damaged rubber linings.

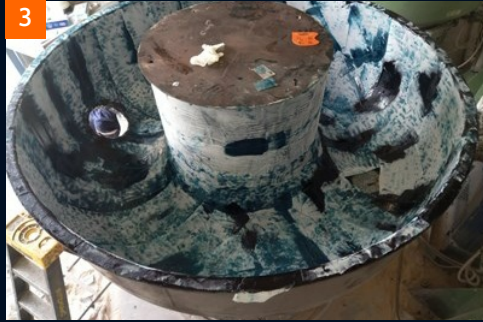
3 : Application of first coat of Belzona 2141 (ACR-Fluid Elastomer) with the Reinforcement Tape Belzona 9341

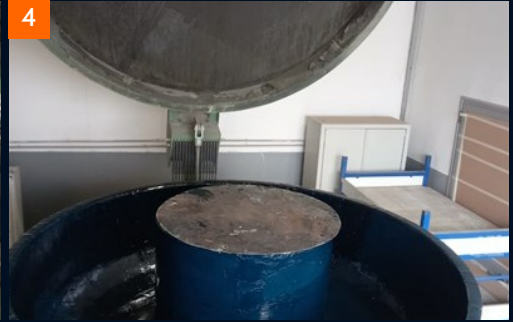
4 : Completed application
