# HOLED HYDRO TURBINE RUNNER REPAIRED WITH BELZONA

ID: 855

Hydro Turbine runner with severe erosion damage

Hydroelectric plant, Vermont

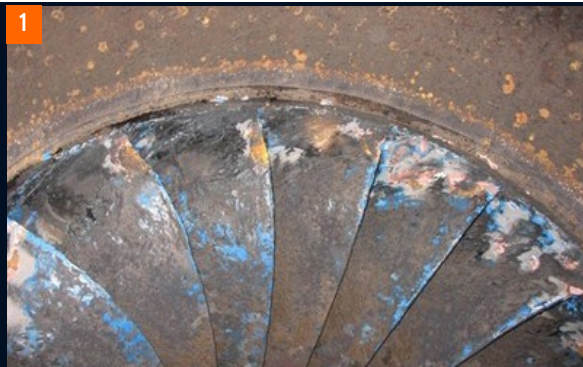
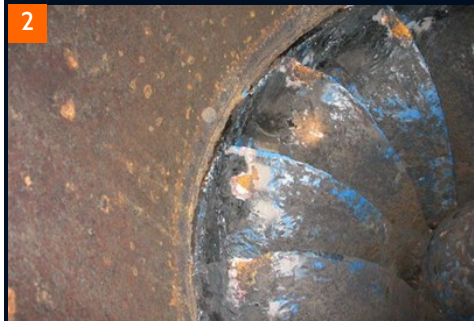
Entrained solids and cavitation caused severe damage to the edges of the runner. Holes and pitting are evident on the runner vanes.

1. Damaged runner with holes
2. Damaged runner with holes
3. Grit blasted clean and ready for coating
4. Finished runner

Application carried out in accordance with CEP-3 & CEP-5. In-situ blast to near white metal finish, rebuilding to fill pits and holes finally overcoating with two coats Belzona® 1341.
