# CRACK REPAIR OF A GAS ENGINE POWER GENERATOR WITH BELZONA

ID: 8554

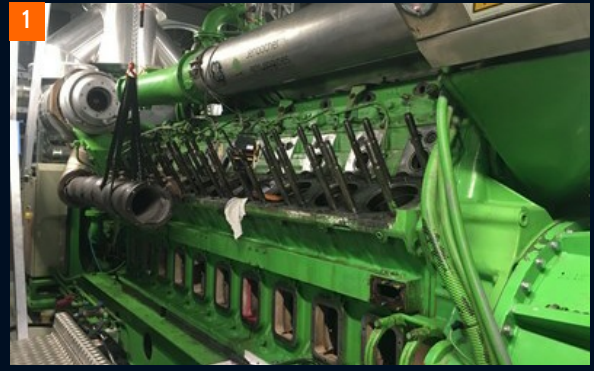
The operator noticed a significant loss of the cooling liquid. After a thorough investigation a crack in the cooling liquid chamber was found.

1. a total shot of the engine.
2. surface preparation through the small hole
3. application is in process
4. repaired crack

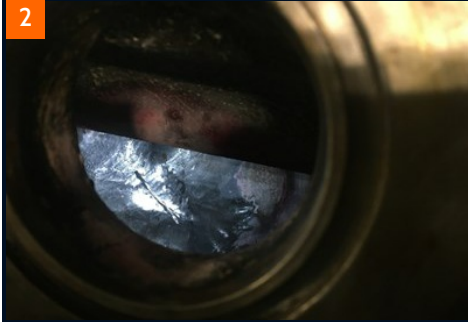
The crack was found deep inside the GE Jenbacher gas engine. The area to be repaired was difficult to access and the regular surface preparation (SA2,5 and 75 microns) was not an option.

Grinding using a small size electric rotary file was followed by a cleaning and degreasing with 9111 prior the application of the mixed 1212. The paste has been applied with a Belzona spatula through an 80mm (3,15") diameter exhaust hole while another colleague controlled and directed from the other side of the engine.
