# REPAIR OF WIND TURBINE BEARING SOCKETS WITH BELZONA

ID: 8556

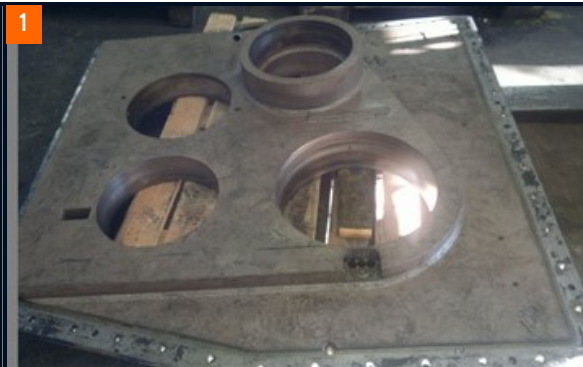
Knockout of bearing sockets - manifested by loud, irregular operation of wind turbine gears.

Image 1: Bearing Socket
