# CATERPILLAR 631 ENGINE REPAIRED WITH BELZONA

ID: 856

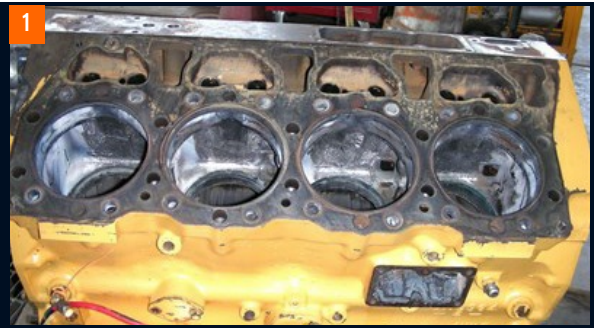
1. Caterpillar 631 engine block
2. Failed "Brand X" repair
3. Prepared surface on 1 of the cylinders showing leaks
4. Completed repair on 1 cylinder

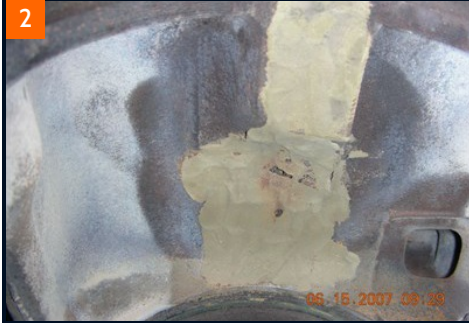
A previous repair with "Brand X" epoxy failed. The owner took it to his own shop & did the work.

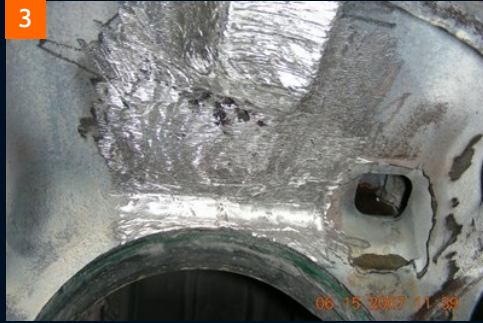
Traces of engine coolant appeared in the lubricating oil test samples indicating erosion in wall of cylinder block
