# PUMP CASE EROSION DAMAGE REPAIR IN GRAVEL MINE

ID: 8589

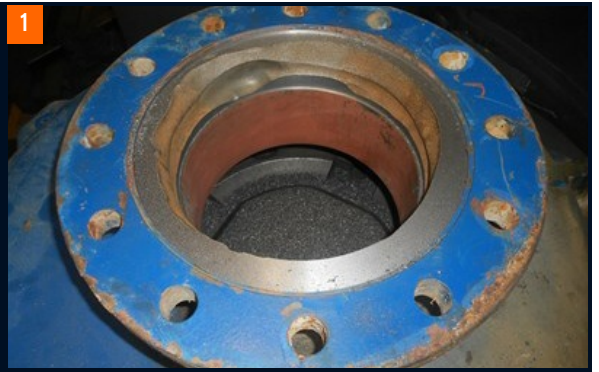
The customers Warman WGR200 suffered from erosion because of the failure of the rubber lining the entrapped solid in the flow found route to the casing surface. The casing material wore until leakage.

- 1-Defective casing
- 2-Defective area
- 3-Defective area after sand blasting
- 4-Finished application with 1321 top-coat
