# TURNTABLE TROUBLE SORTED WITH BELZONA

ID: 859

Worn Spline and Gear Drive

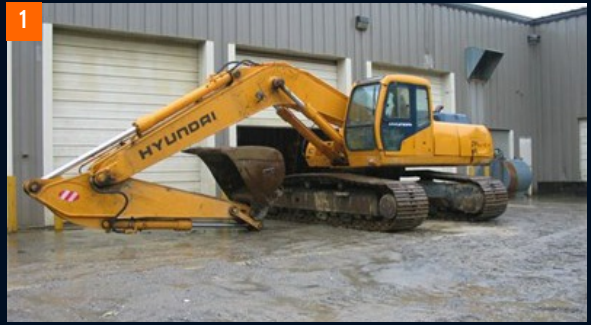
Spline drive and gears were so old and worn that the main deck turntable on the excavator could not operate.

Excavator unable to rotate  
Worn gear  
Worn drive  
Worn gear and drive

Application was carried out in accordance with Belzona System leaflet MPT-5.

Belzona 1111(Supermetal)
