# BELZONA RE-SEATS BEARING ON RUDDER SHAFT

ID: 8590

Rudder shaft was worn under the bearing requiring repairs to the shaft for full bearing contact.

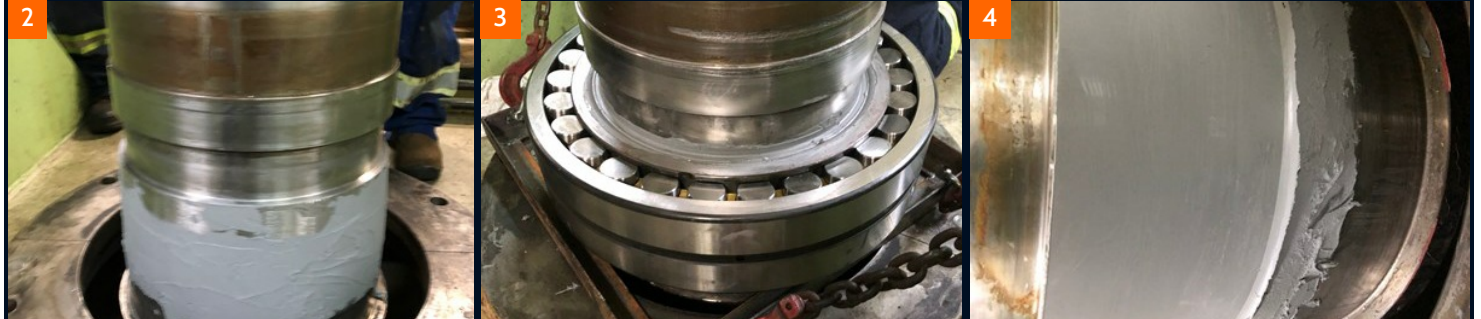
1. Damaged shaft after preparation.
2. Belzona 1121 applied onto the shaft and bearing.
3. Bearing lowered into position for curing.
4. Bearing removed and Belzona 1121 inspected.

The new bearing was used as a former using the slip method following a modified version of Belzona Know How repair leaflet SOS-9. Two coats of Belzona 9411 release agent were applied on the inside of the new shaft bearing and allowed to fully dry. Shaft was prepared using power tools to remove all corrosion deposits and loose substrate. Belzona 1121 Super XL-Metal was mixed and applied by brush onto the shaft and the inside of the bearing. Additional Belzona 1121 was troweled onto the shaft and bearing. Bearing was lowered onto the shaft, excess Belzona 1121 was removed, and the repair was allowed to cure for 24 hours. The bearing was removed to inspect that there was at least 80% contact between the shaft and bearing.
