# BELZONA REPAIRS CRACKED HEAD

ID: 8593

A stainless steel head to a pressure vessel has a hairline crack along a weld.

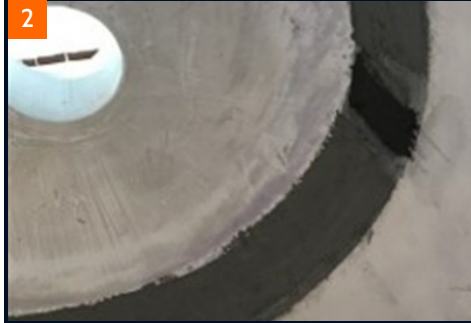
1. Cracks found with dye penetrate
2. 1st coat of Belzona 1593 and internal SW II after sweep blast
3. External SuperWrap II
4. Final coat of Belzona 1593

Cracks were found using dye penetrate. All cracks were terminated, holes drilled and tapped 3/8" deep, and set screws installed. Belzona 1511 was used to flush out and rebuild the circumferential weld. Belzona SuperWrap II was applied on both the internal and external surface as a 6 layer system. Belzona 1593 was applied to the internals as a 2 coat system for additional protection.
