# BELZONA SUPER WRAP II REPAIR TO MAIN SEWAGE PIPE

ID: 8594

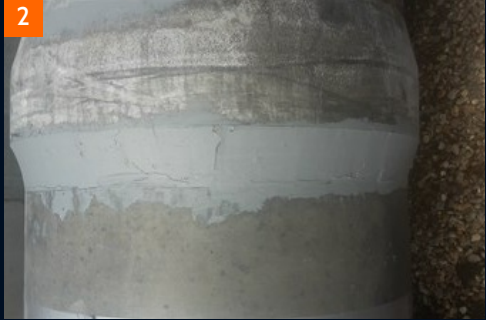
2

- 1. Cracked Sewage pipe
- 2. Belzona 1111 (Super Metal) repair
- 3. Release film applied
- 4. Three wraps of Belzona SuperWrap II

Surface preparation was completed using grinders and specialist power tools. A fillet of Belzona 1111 (Super Metal) was then applied on the step side of the joint. Repairs were then completed on the major leak area using the Belzona SuperWrap II system to a non-compliant standard. Three wraps of Belzona SuperWrap II were completed with a 50% overlap. The system will be applied as a complete circumferential wrap extending the repair area up to 1 linear meter. Once completed, Belzona Release Film was applied over the wet area in a spiral fashion and secured. Once fully cured, the Release Film was removed, and the repair was completed.

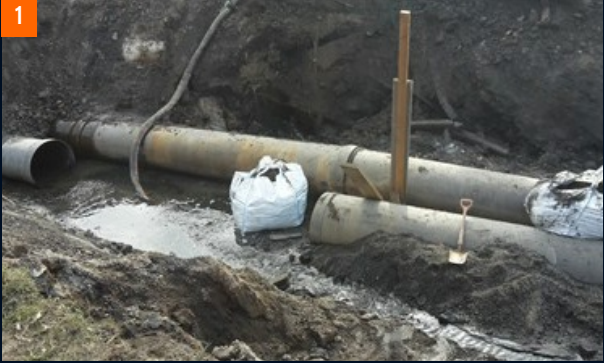
1

Following impact damage, the 800mm diameter, GRP sewerage pipe had cracked. The crack ran around the complete circumference of the pipe.
