# BELZONA REPAIR TO MARINE ENGINE BLOCK

ID: 86

12 Cylinder Diesel engine from ship

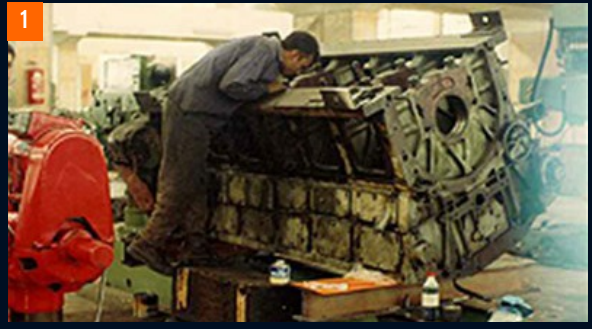
Crankshaft Bearing shells spun in housing causing wear in the housing necessitating rebuilding before new shell bearings installed.

1. Application underway to the engine crankcase
2. Belzona 1111 applied to housing
3. Line boring of housings underway
