# BELZONA SUPERWRAP II REPAIR ON 2IN. ELBOW - LDHI TRANSFER LINE

ID: 8627

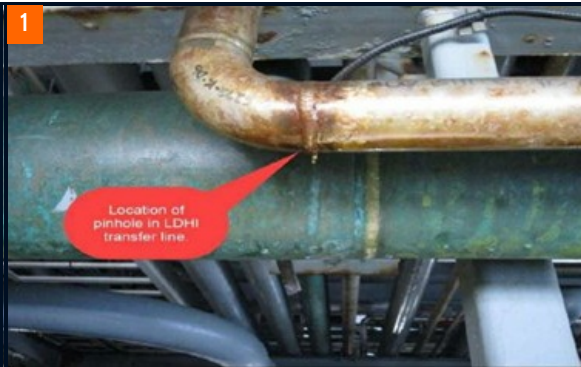
The problem was a pin hole leak that was found on a 2" pipe around the weld seam of an elbow, caused by external corrosion. This was an LDHI transfer line on an offshore platform in the Gulf of Mexico. Operating Temperature is 100F and Design Pressure of 150psi. A quick and compliant repair was desired by client to stop the leak and continue normal operations.

1. Location of pin hole leak in the pipe.
2. After surface prep was completed.
3. Release Film applied.

1. Fill in defect with 9611 to stop leak
2. Power tool clean to bare metal - SSPC-11
3. Repair pitting with Belzona 9611 and Belzona 1161.
4. Apply 3 wraps of SW II - 1982/9381(84mm). 10" total axial extent of repair.
