# ROLL MILL SLURRY PUMP REPAIR WITH BELZONA

ID: 868

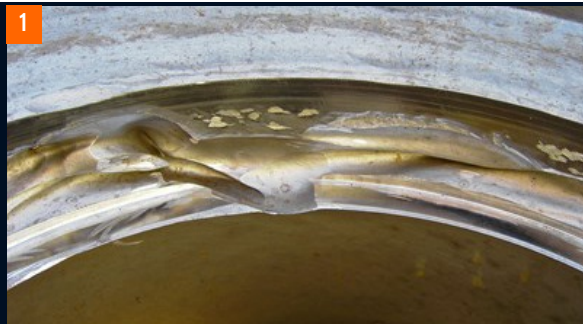
The wear ring disintegrated allowing severe damage to the pump casing. Their need was to repair the casing and find a way to bind the new wear ring in place. If this could not be done a new casing would have to be ordered.

1. Damage inside wear ring area
2. View inside pump casing
3. New stainless steel wear ring
4. Casing repaired and wear ring installed
