# COAL CONVEYER REPAIRED WITH BELZONA ELASTOMER

ID: 876

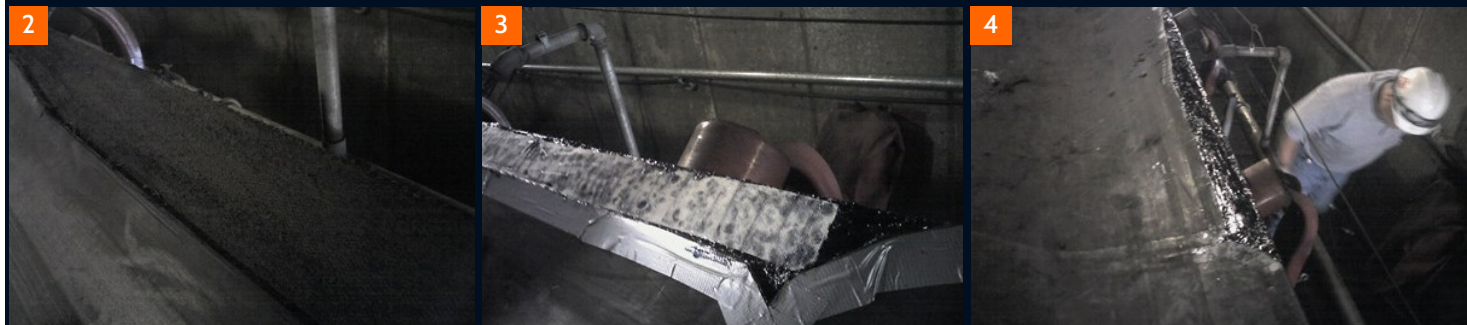
The belt had delaminated and lost the top two plies in areas. Plant officials worried that the belt integrity was in jeopardy due to the extensive damage.

1. Belt damage
2. Another view of the damaged area
3. Application underway with reinforcement tape being embedded in elastomer
4. Completed repair

Belt was repaired in accordance with Belzona Know-How System Leaflet SHM-1.
