# CORRODED FLANGE AREA REBUILT WITH BELZONA

ID: 8853

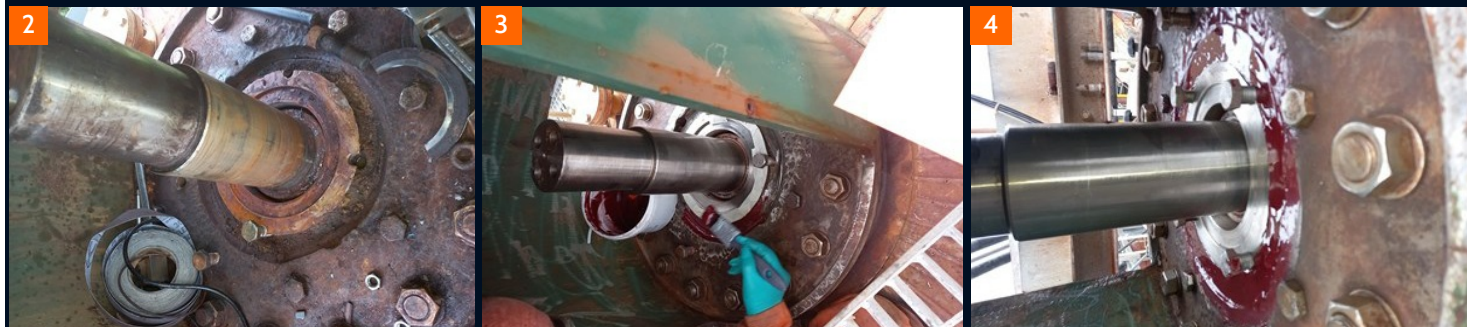
Welding in the area was not feasible due to the proximity of a mechanical seal & the depth of the metal loss

A mild steel flange section at the top of a vessel had become corroded due to leaking acetic acid. A repair was required to reinstate the lost metal & provide future protection.

1. Corroded area around mechanical seal
2. Close up
3. Area prepared & wetted out with Belzona 4331
4. Belzona 4331 filled to replace the lost metal

The corroded area was prepared using power tools to achieve a surface profile. It was degreased & Belzona 9411 release agent was applied to the bolts that fitted around the mechanical seal housing. Belzona 4331 was then used to wet out the area before being poured in to fill the areas of metal loss.
